Document Title: FPA AIT Test Results

Document Number: VIS-TRE-RAL-06036-0100

IR Camera

FPA AIT Test Results

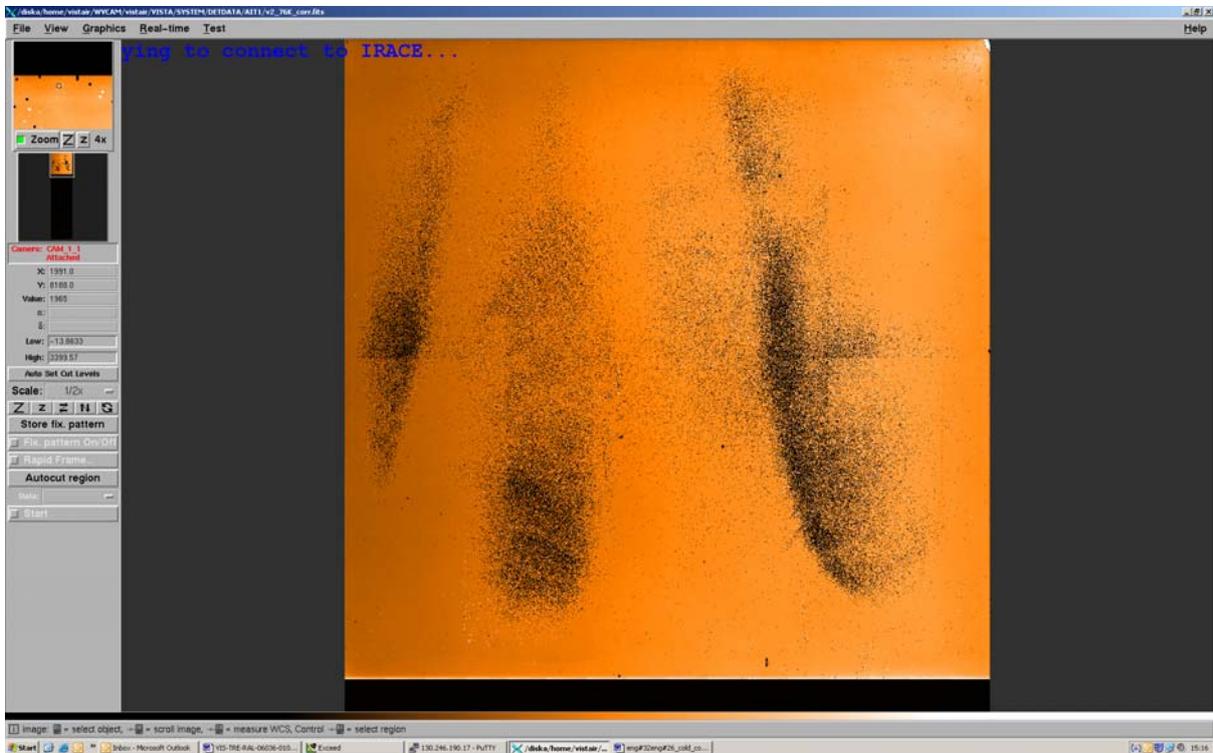
Figure 1 Double correlated cold image taken with engineering grade detector #32, during Camera AIT-1

Figures 1 and 2 show double correlated cold images taken with engineering grade detectors #32 and #26, during Camera AIT-1.

Figures 1 and 2 compare well with images taken at Raytheon [RD 3] and the ATC [RD 11, RD12].

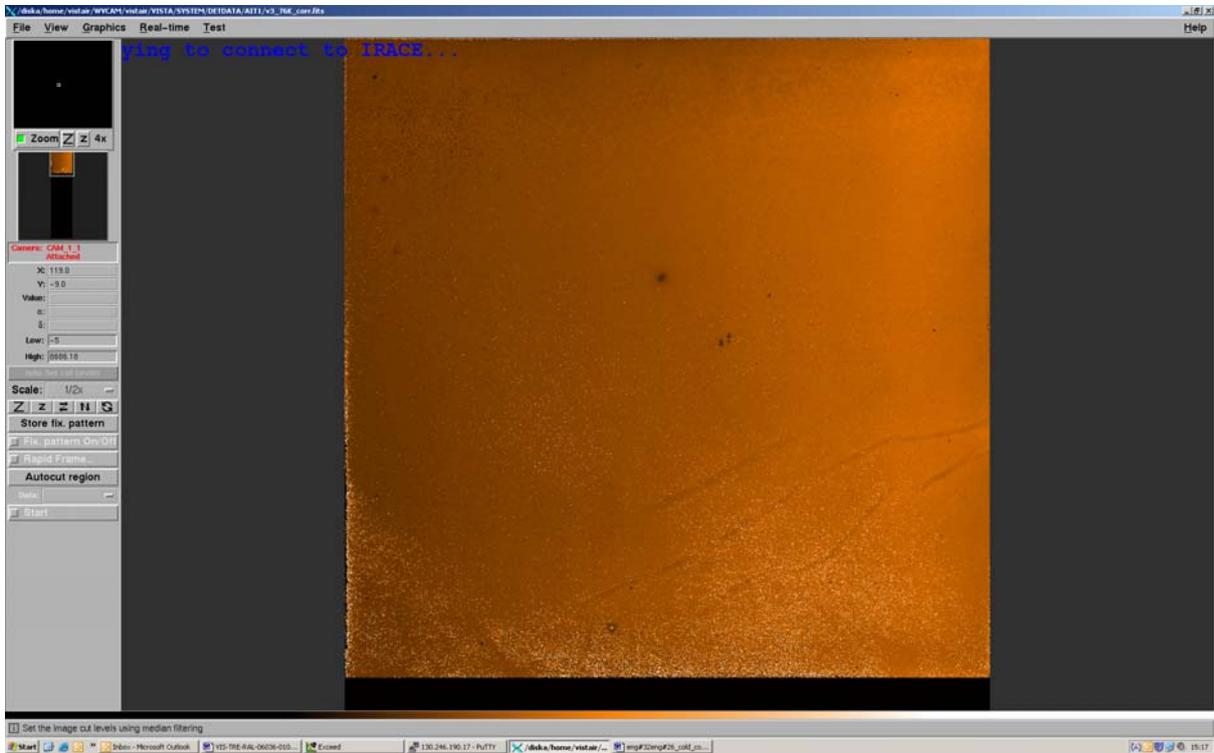
Figure 2 Double correlated cold image taken with engineering grade detector #26, during Camera AIT-1

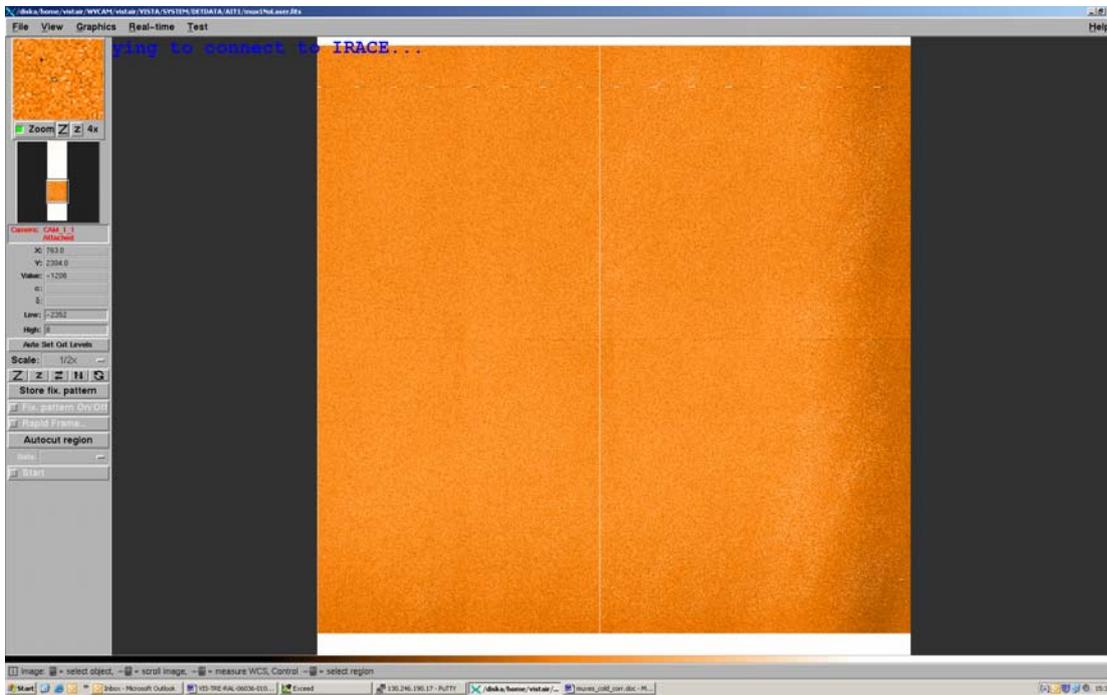
Figure 3 Double correlated cold image taken with mux 1, during AIT-1

Figures 3, 4, 5 and 6 shows double correlated cold images taken with the four muxes, during Camera AIT-1.

Operation of the muxes, using the same bias voltages as the engineering grade detectors, was not entirely satisfactory. Despite this, there is reasonable similarity between muxes 1, 2 and 3 and the results obtained at the ATC [RD 10] (mux 4 was not tested at ATC, as it was on loan from ESO).

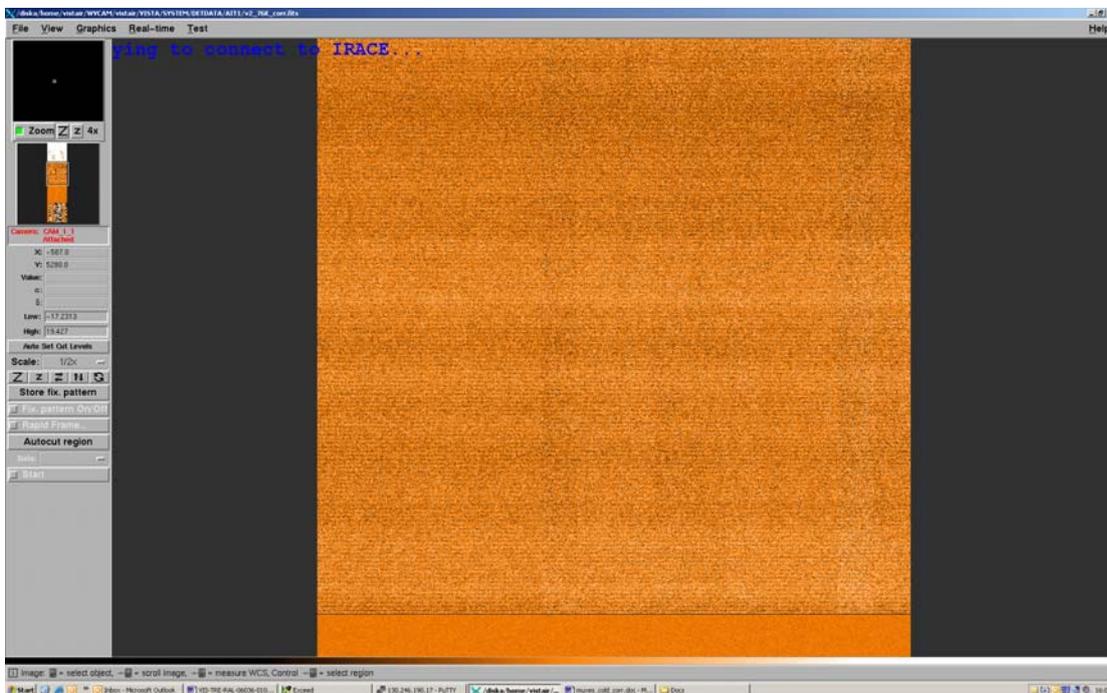
Figure 4 Double correlated cold image taken with mux 2, during AIT-1

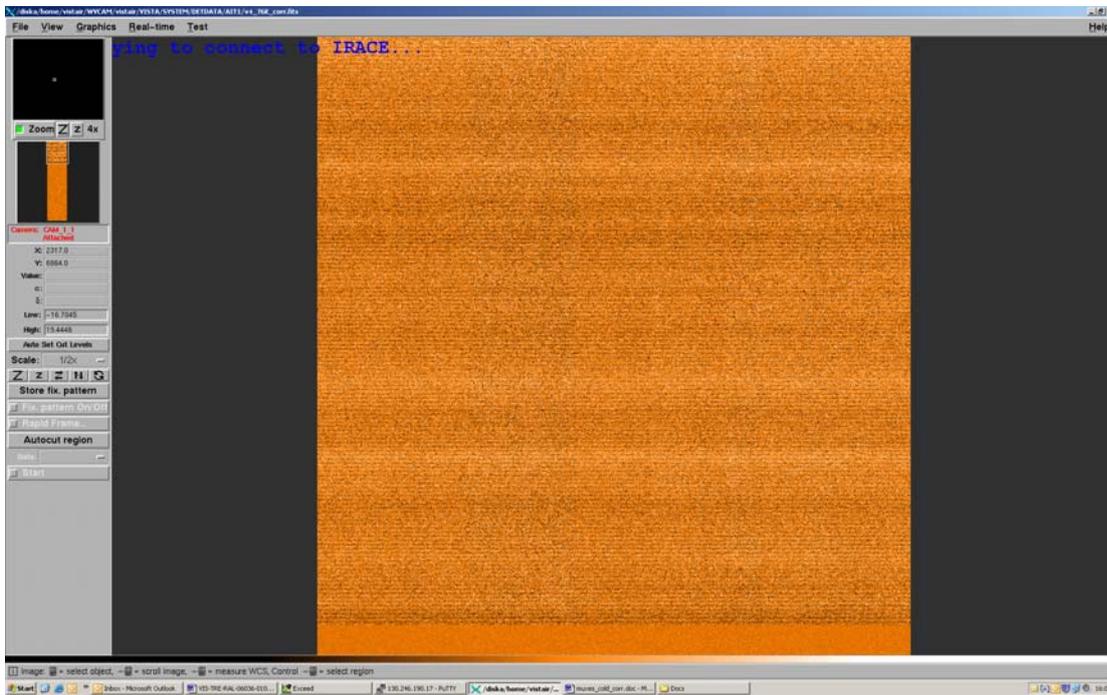
Figure 5 Double correlated cold image taken with mux 3, during AIT-1

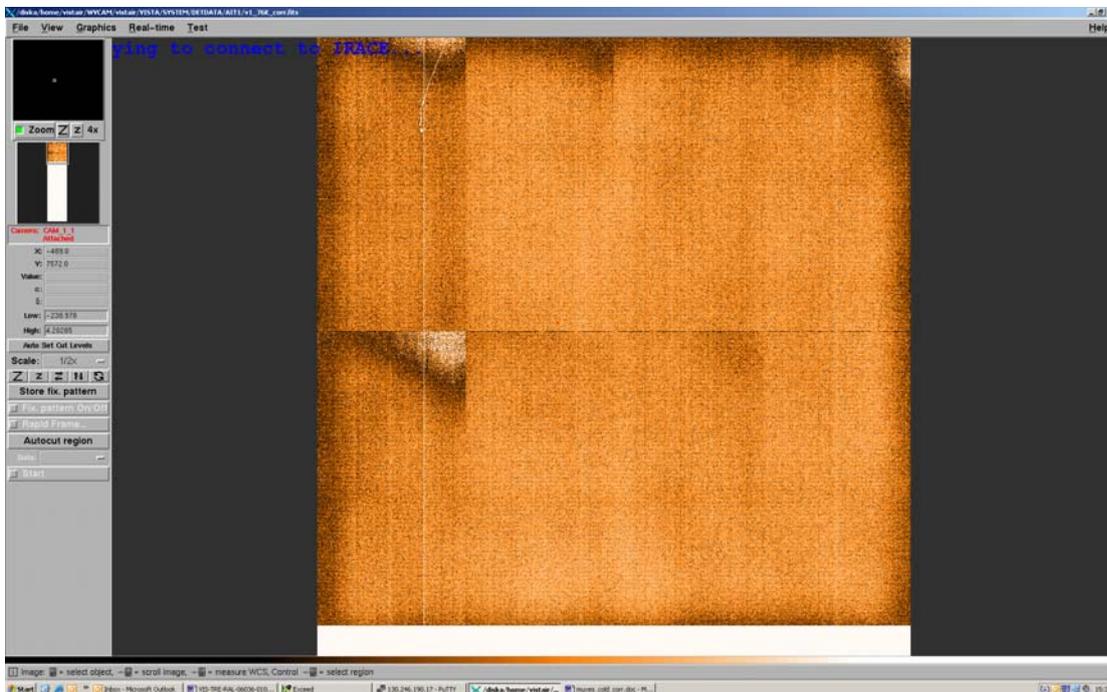
Figure 6 Double correlated cold image taken with mux 4, during AIT-1

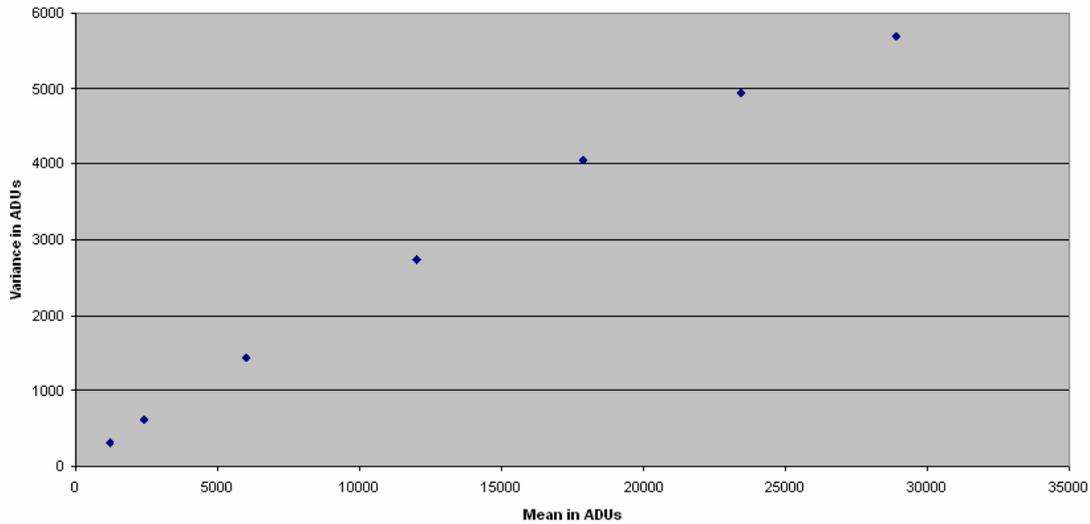
Eng #32 noise & gain test (AIT-1)

Figure 7 Photon transfer plot of engineering grade detector #32, during Camera AIT-1

- Pairs of double correlated images are taken for a range of exposure times.
- The first exposure in each pair is stored as a fixed pattern by the display.
- The second exposure in each pair has the first image subtracted from it, by selecting Fixed pattern On.
- The statistics option is then used to measure the standard deviation in a box roughly 1K x 1K. This measured standard deviation is actually root 2 times the real standard deviation of a single image, due to the differencing of the two images.
- The means, from the single images, and the measured standard deviations from the subtracted images are entered into a spreadsheet which calculates the variance and plots variance against mean.
- The resulting plot is the classic photon transfer plot in which the reciprocal of the slope represents the system gain in e-/ADU and the intercept represents the variance of the read noise.

Figures 7 to 10 show the resulting photon transfer plots for engineering grade detectors #32 and #26, using this simplified noise and gain test.

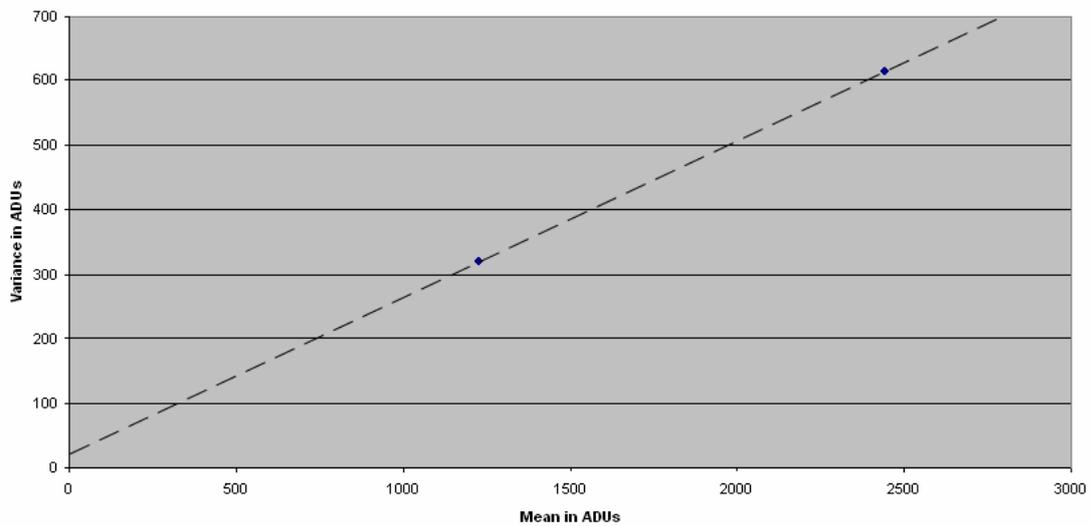
Eng #32 low signal part of noise & gain test (AIT-1)

Figure 8 Low signal part of photon transfer plot of engineering grade detector #32, during Camera AIT-1

Table 4 shows the results obtained from figures 8 and 10 (the low signal parts of the photon transfer curves).

Detector	System gain in e-/ADU	Read noise standard deviation in e-
Engineering grade #32	4.03	20.2
Engineering grade #26	3.78	35.9

The system gains measured compare reasonably well with the gain measured at the ATC [RD 11, RD 12], provided that the difference in preamp gains is taken into account.

The noise measured for detector #32 agrees reasonably with the noise measured at the ATC. The noise measured for detector #26, however, is considerably higher than the noise measured at the ATC. This is considered to be due to the simplified noise measurement method, in which bad pixels are not removed.

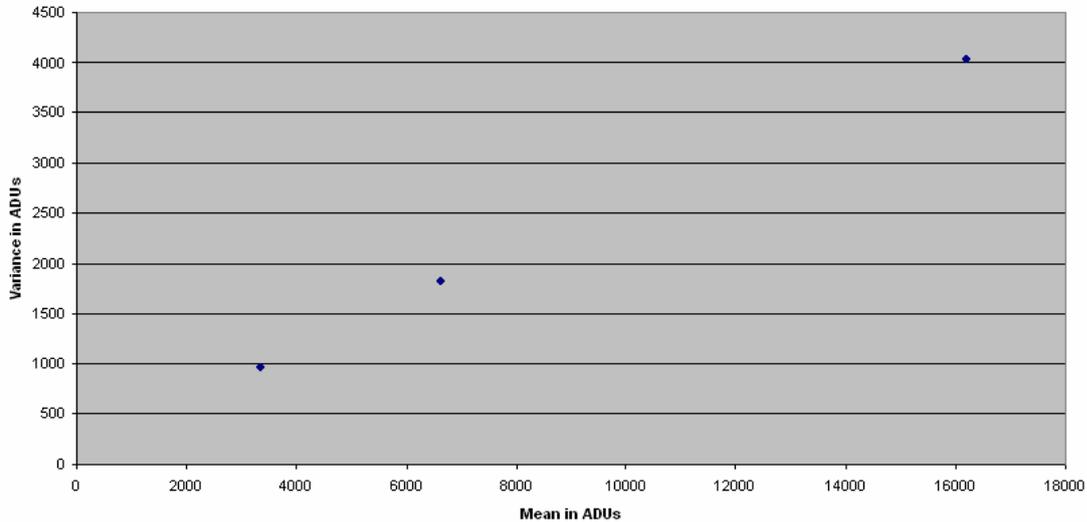
Eng #26 noise and gain test (AIT-1)

Figure 9 Photon transfer plot of engineering grade detector #26, during Camera AIT-1

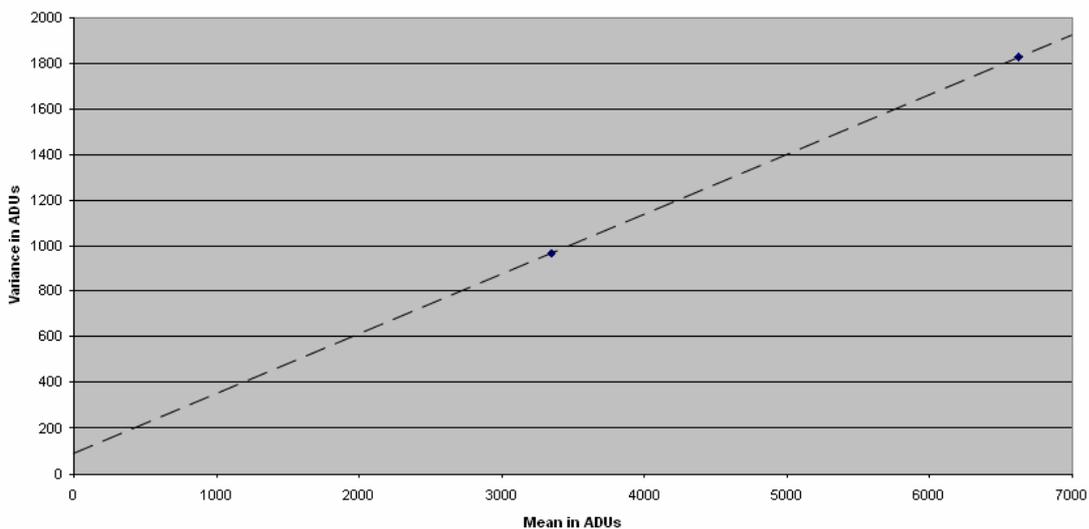
Eng #26 low signal part of noise & gain test (AIT-1)

Figure 10 Low signal part of photon transfer plot of engineering grade detector #26, during Camera AIT-1

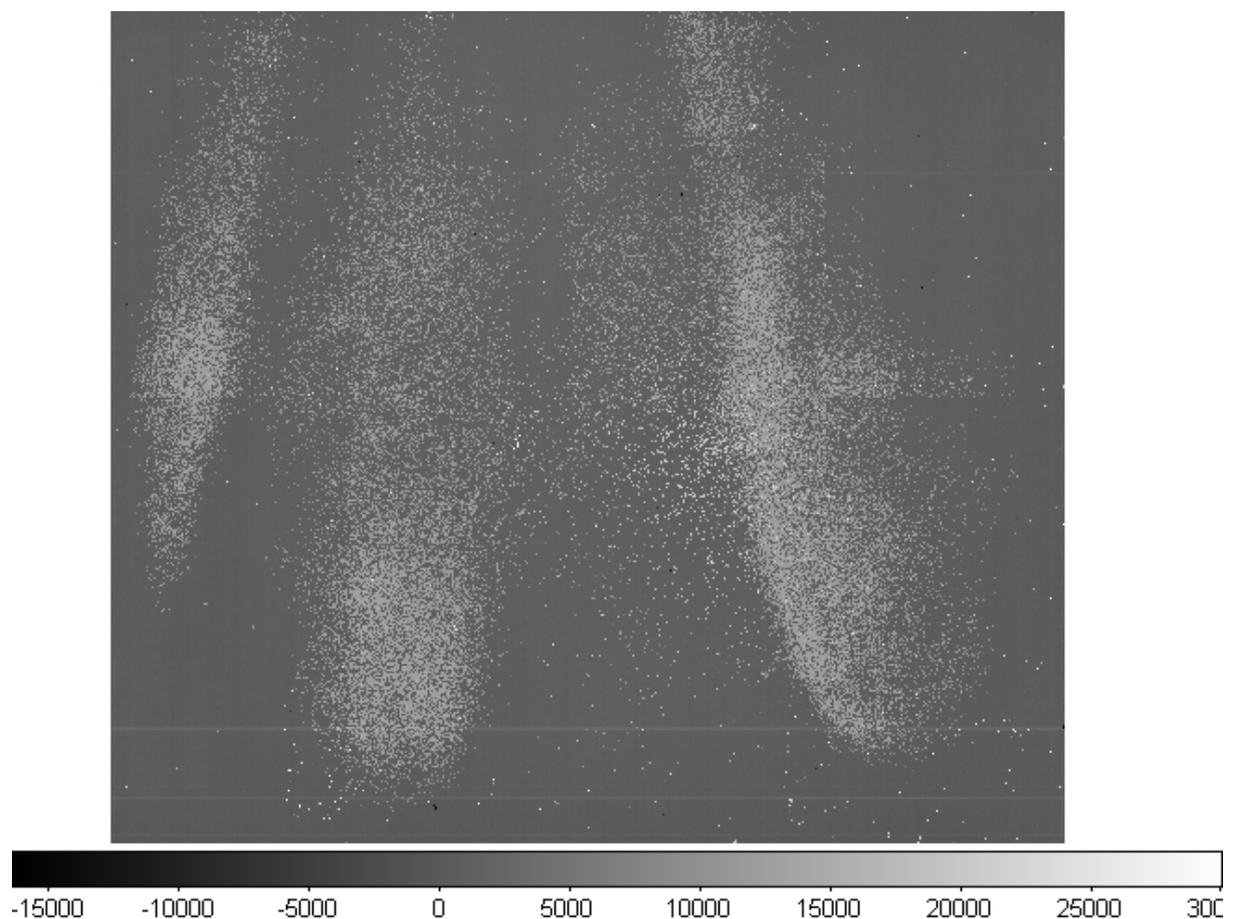
Figure 11 Uncorrelated 1 second exposure cold image taken with engineering grade detector #32, during AIT-2

Figure 11 shows an uncorrelated 1 second exposure image taken with engineering grade detector #32, during Camera AIT-2.

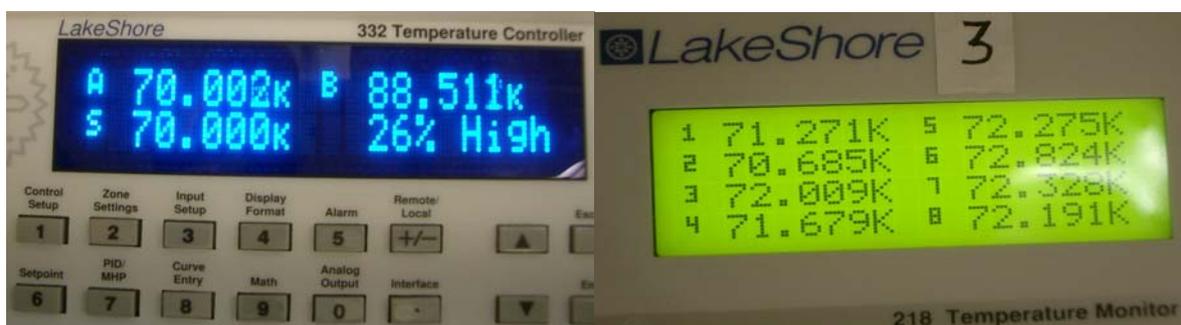
These photographs show the Lake Shore 332 display of actual temperature, temperature set point and the heater power and the Lake Shore 218 display of the temperatures of 8 of the VIRGO detectors.

Figure 12 Lake Shore temperature displays during Camera AIT-3a1

Figure 11 shows photographs of the front panels of the Lake Shore 332 temperature controller and Lake Shore 218 temperature monitor #3.

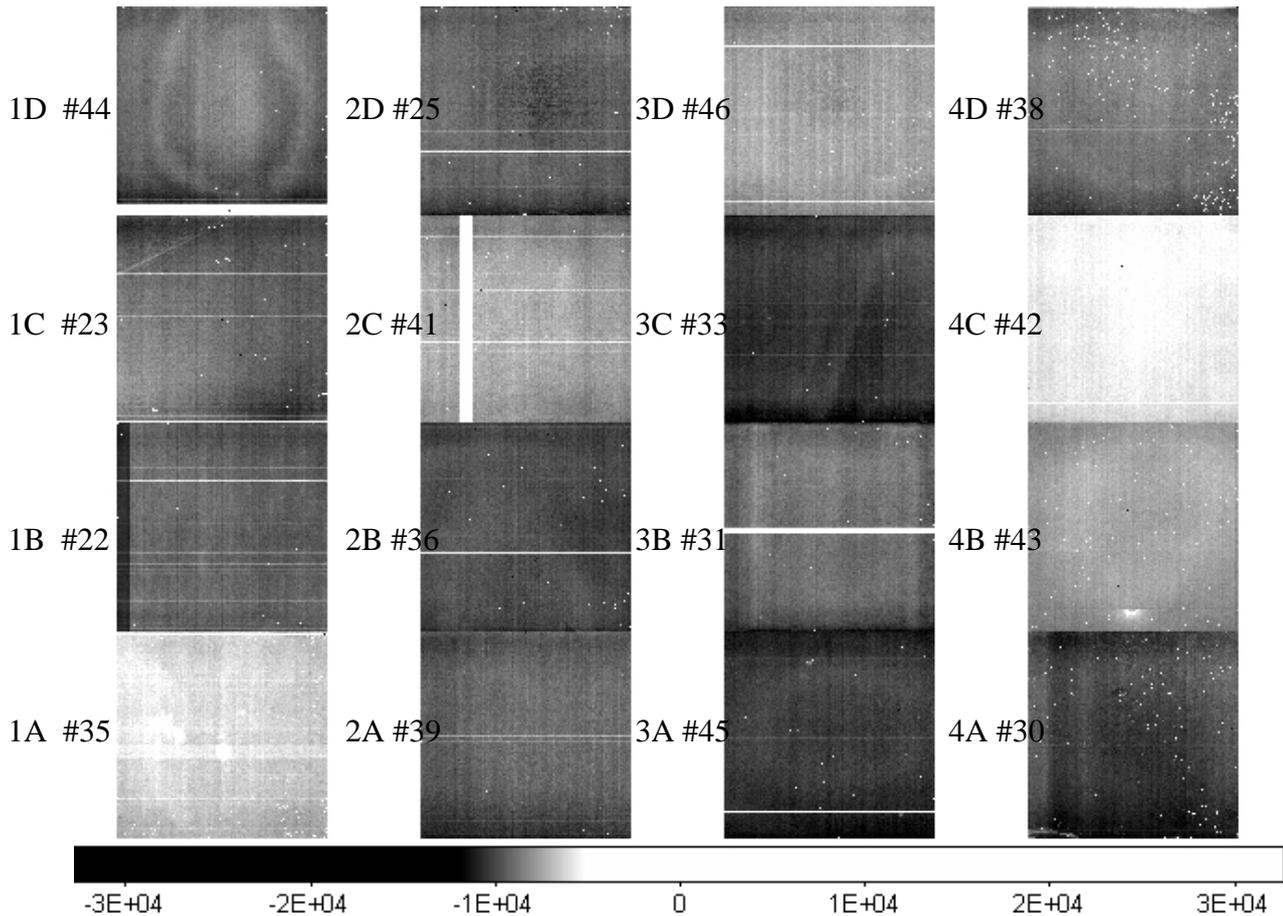
Figure 13 1 s exposure uncorrelated cold image taken during Camera AIT-3a1

It can be seen from figure 13 that channel 1 on detector #22 (position 1B) and channel 4 on detector #41 (position 2C) were not working properly. This was later traced to faulty cable/connectors which were successfully repaired.

Figure 13 shows a 1 second exposure uncorrelated cold image, with all 16 science detectors, taken during AIT-3a1.

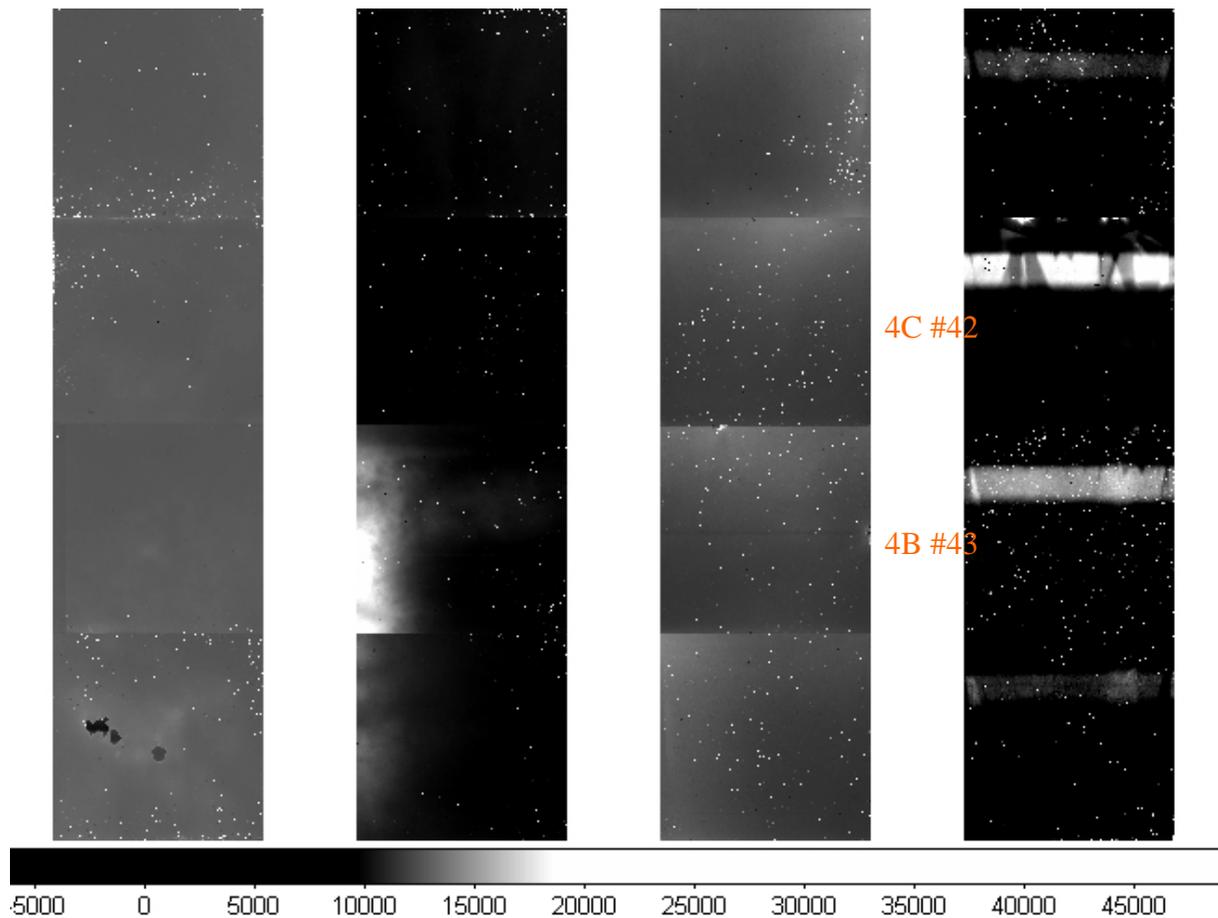
Figure 14 60 s exposure CDS cold image taken during Camera AIT-3a1

It can be seen from figure 14 that there is a distinctive pattern of stray light, particularly on detectors #42 (position 4C) and #43 (position 4B).

Figure 14 shows a 60 second exposure double correlated cold image, with all 16 science detectors, taken during AIT-3a1.

Considerable went into understanding the cause of this effect and finding ways of minimising it, during subsequent Camera AIT and ‘all-up tests’ campaigns.

Comparison of figure 15, with figure 14, shows that the interim aluminium fence around the FPA has reduced the patterned structure of the stray light.

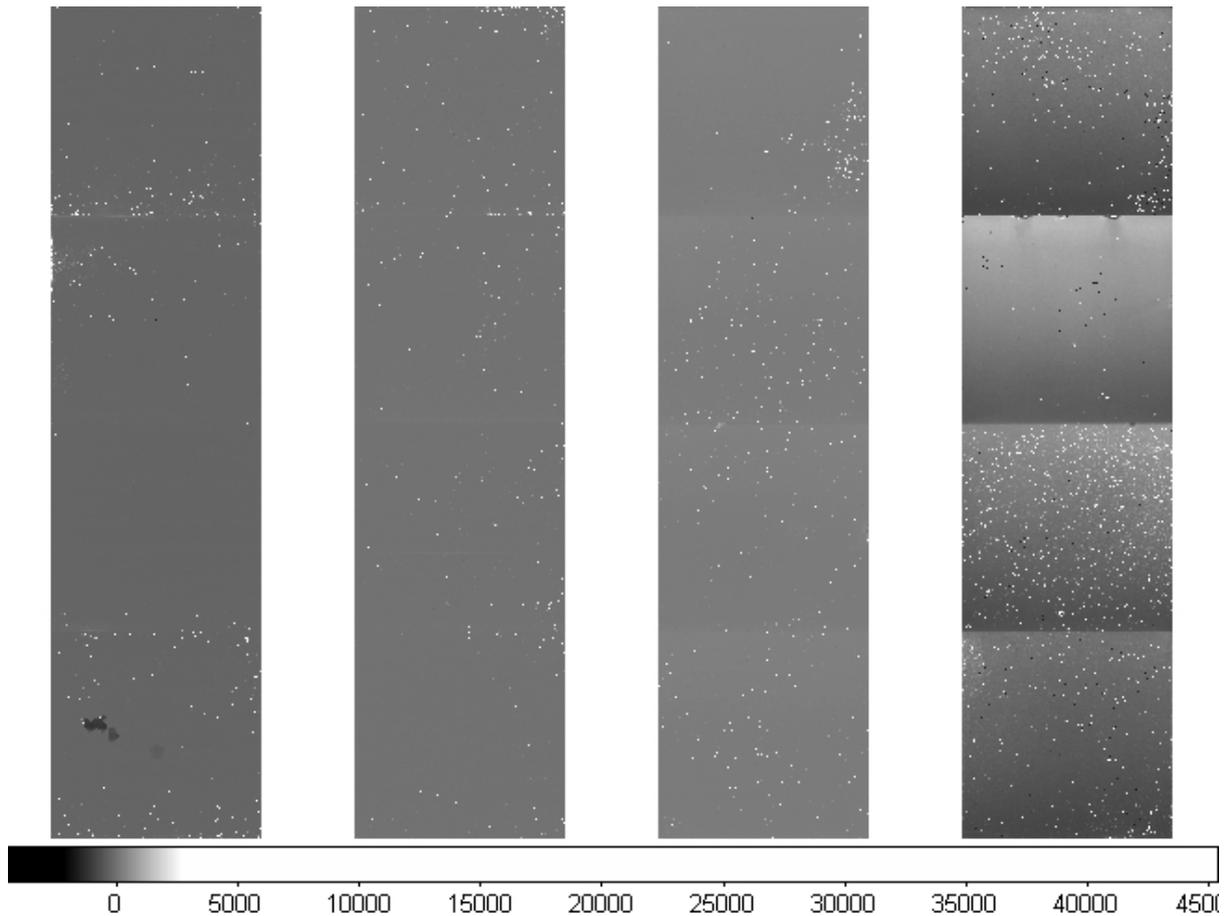
Figure 15 60 s exposure dark CDS cold image taken during Camera AIT-4b

Figure 15 shows a double correlated cold image taken during Camera AIT-4b.

Comparison of figure 16, with figure 15, shows that the additional shielding at the back of the FPA has further reduced the stray light.

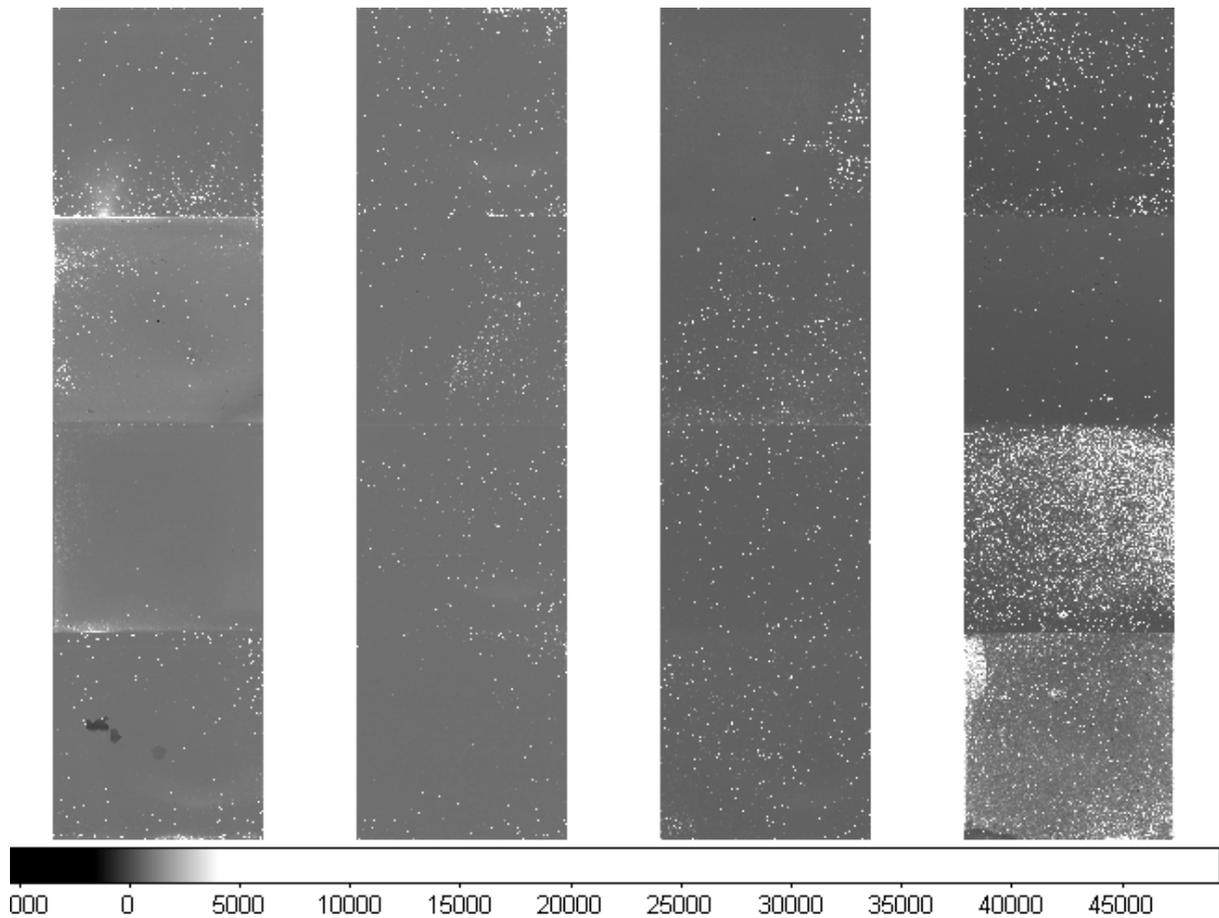
Figure 16 1200 s exposure CDS cold image taken during Camera AIT-4c

Figure 16 shows a double correlated cold image taken during Camera AIT-4c.

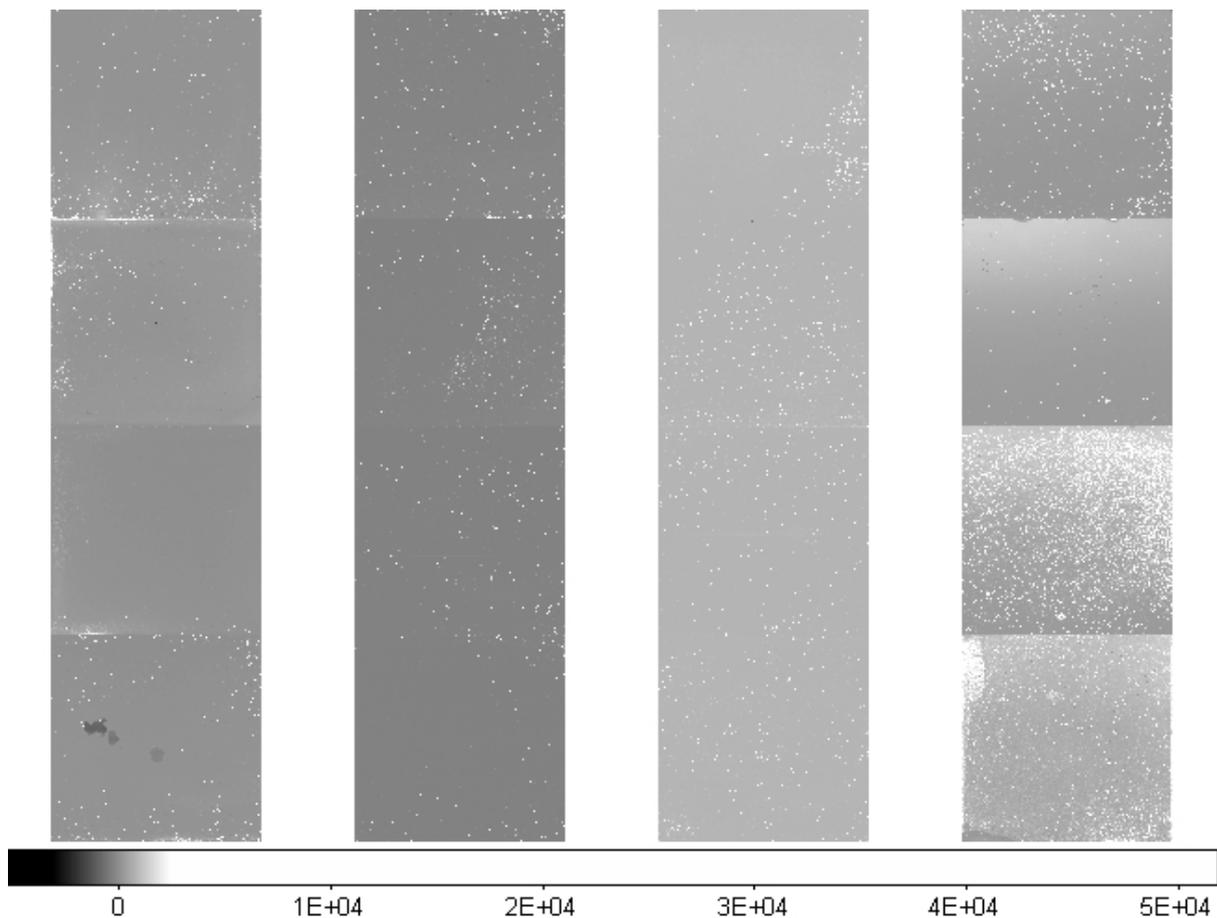
Figure 17 360s exposure CDS cold image taken during Camera AIT-4c

Figure 17 shows a double correlated cold image taken during Camera 'all-up tests'.

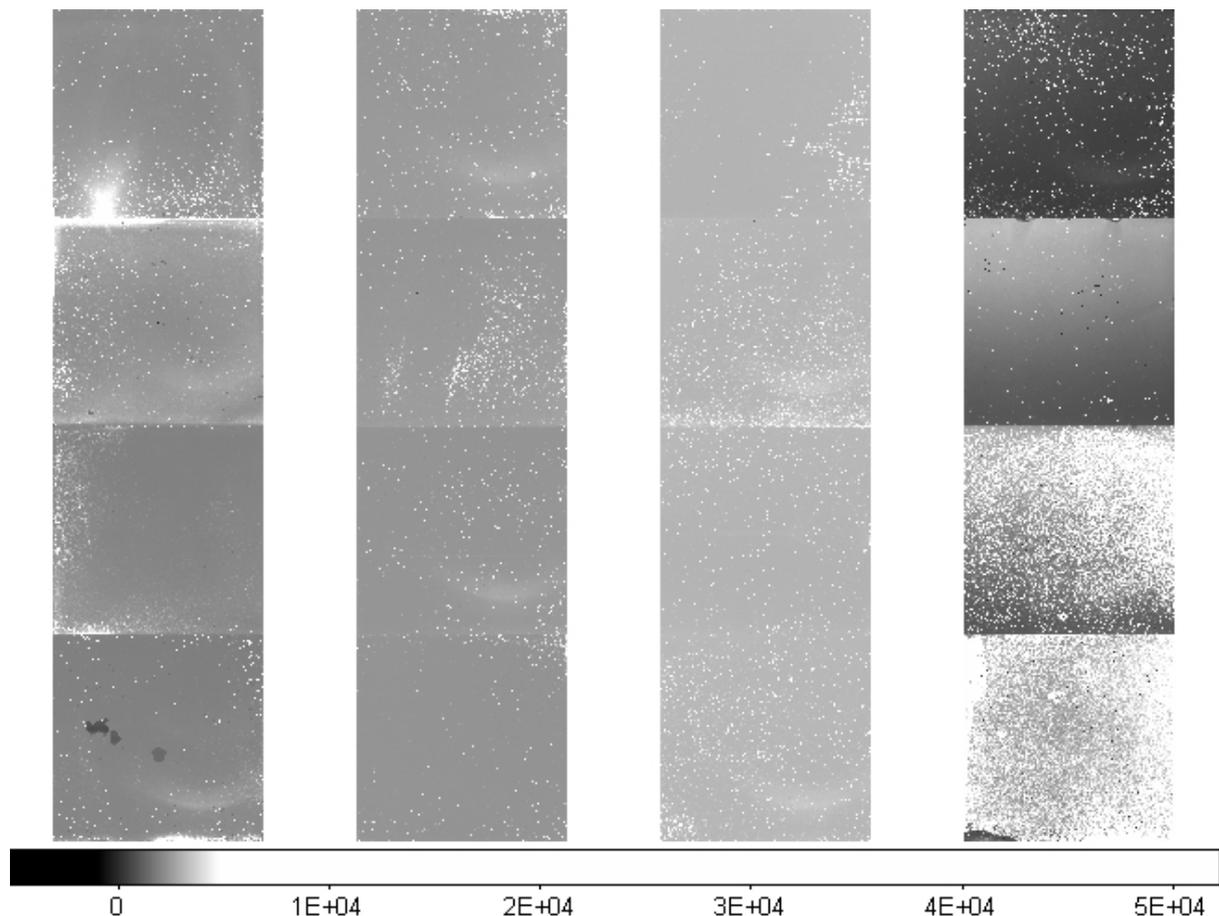
Figure 18 3600s dark exposure CDS cold image taken during Camera AIT-4d

Figure 18 shows a cold dark CDS image taken during AIT-4d, prior to failure of detector #31.

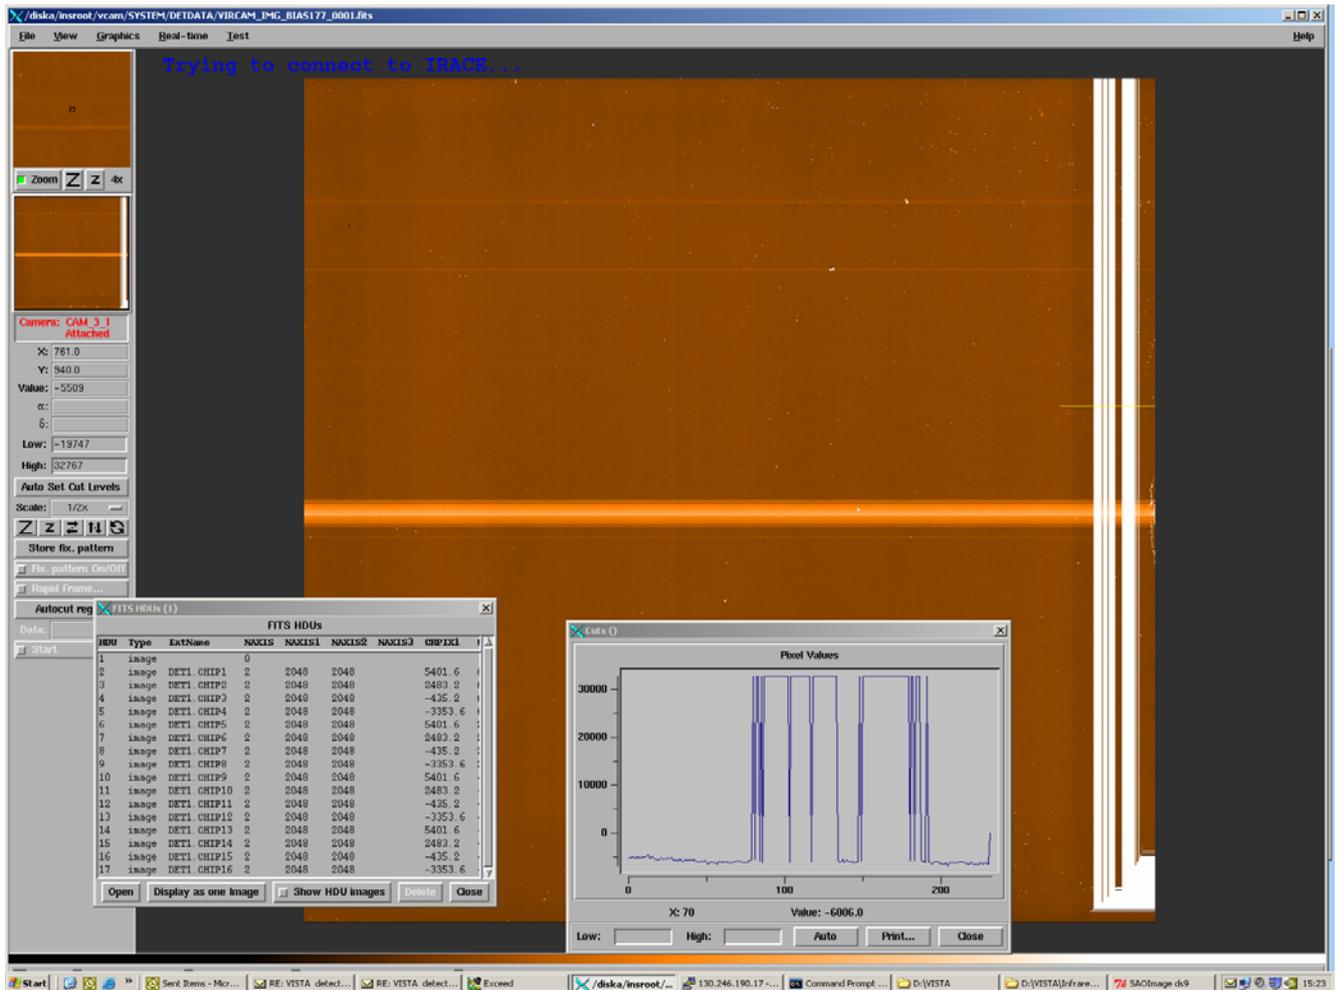
Figure 19 shows a cold dark uncorrelated image taken with detector #31 on 26 June 2006. The failure of channels 15 and 16 of the readout are clearly visible.

Figure 19 Uncorrelated image taken on 26 June 2006, showing detector #31 failure

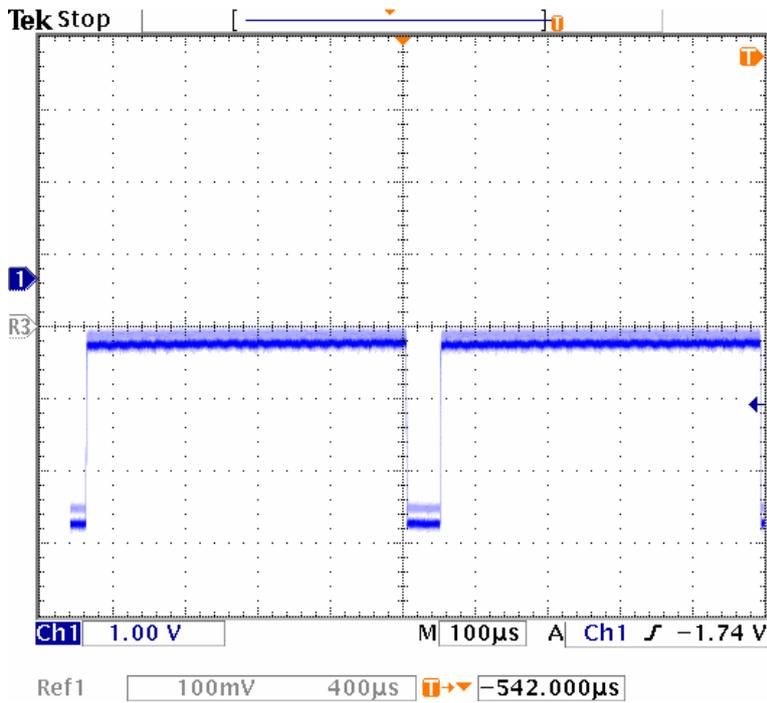
Figure 20 Scope trace of detector #31 channel 14 readout (warm)

Figure 20 shows good channel 14 and figures 21 and 22 show the bad channels 15 and 16.

Figures 20, 21 and 22 shows oscilloscope waveforms, monitored at test points in the IRACE AQ16 module, of the composite video signals of channels 14, 15 and 16 of detector #31, during readout (warm).

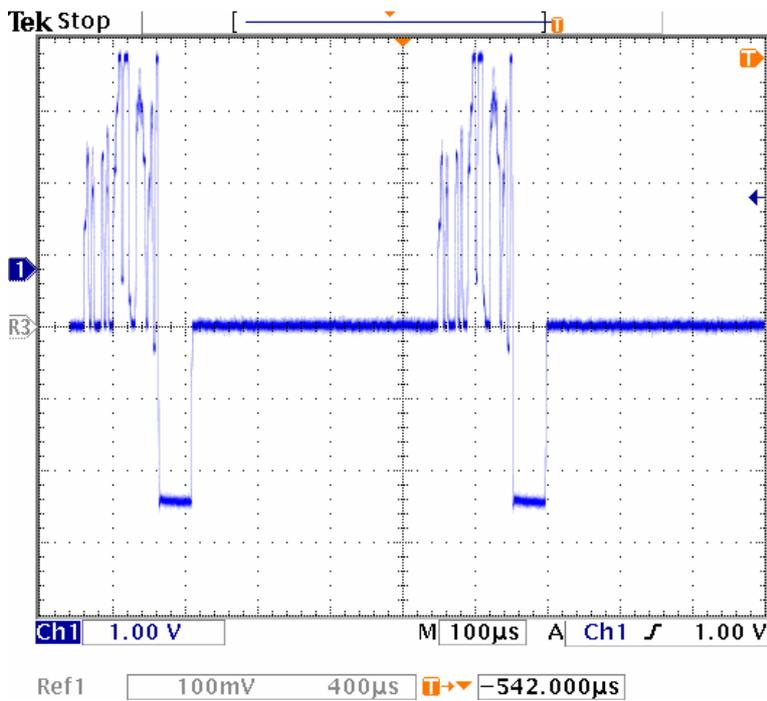
Figure 21 Scope trace of detector #31 channel 15 readout (warm)

- Both halves of the differential signals, on channels 15 and 16, were faulty.
- Swapping cables and/or IRACE channels did not fix the problem.

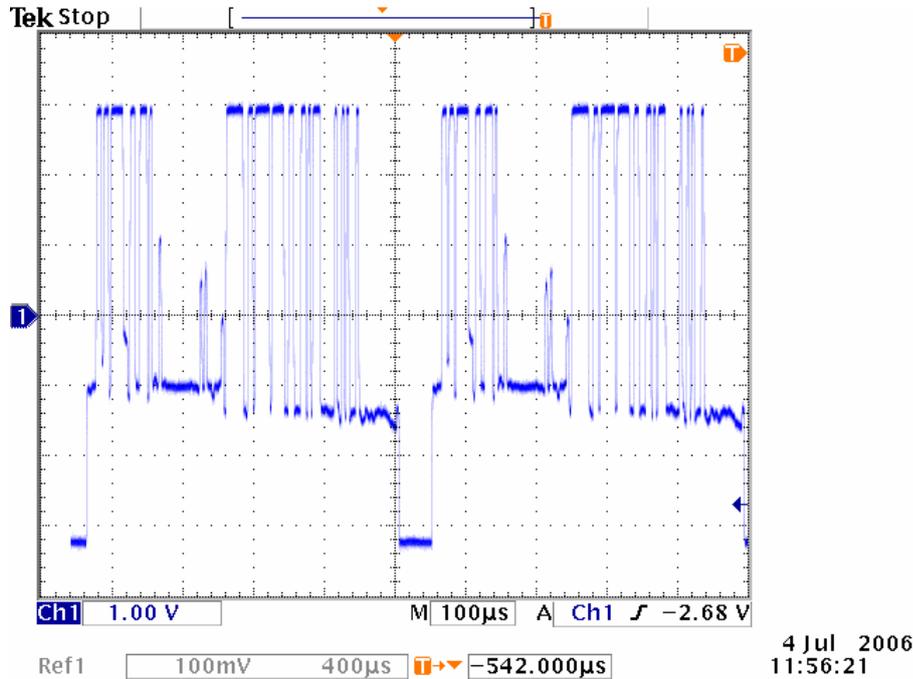
Figure 22 Scope trace of detector #31 channel 16 readout (warm)

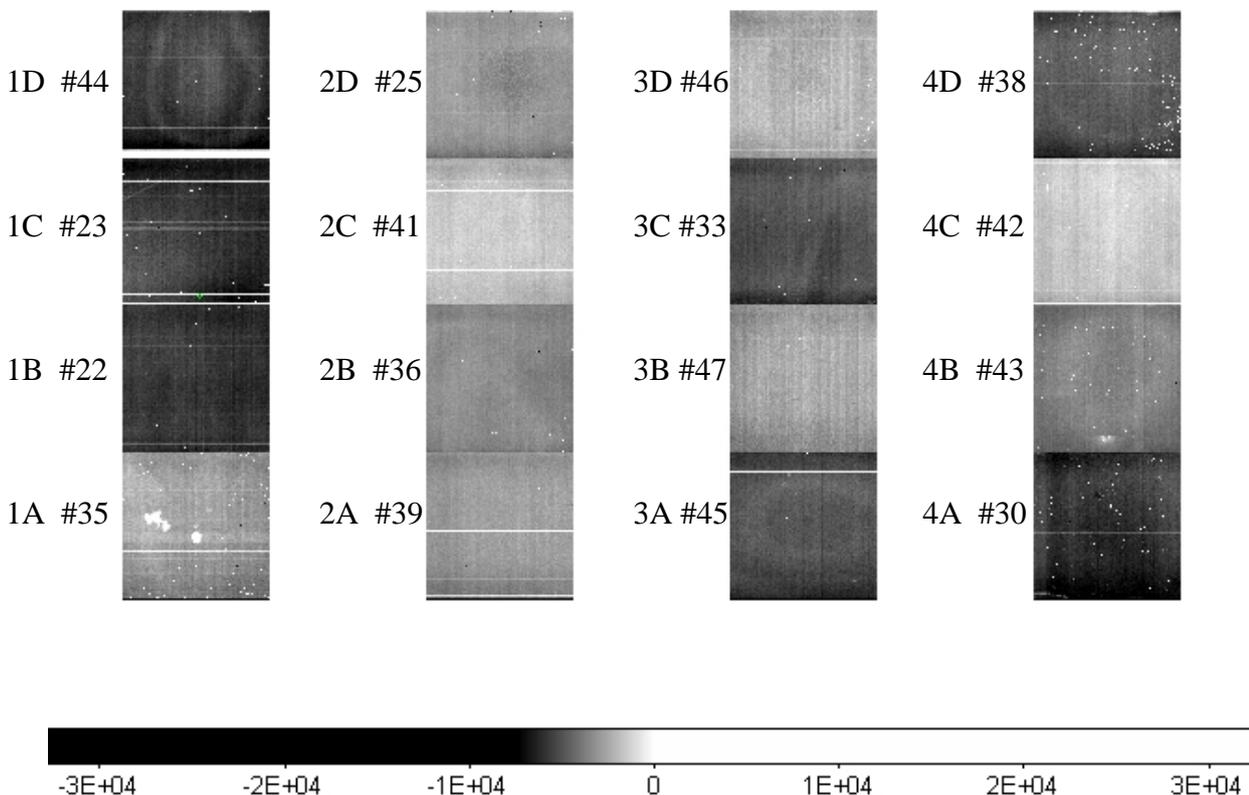
Figure 23 Uncorrelated 1 sec cold image taken during Camera 'all-up tests b'

Figure 23 shows that the replacement, of the faulty detector #31, by the new detector #47 has been successful.

Figure 23 also shows a small effect in channel 12 of detector #43 (position 4B), which was pointed out in RD 9.

Investigation of images has shown that this is a very small effect, which is not expected to significantly degrade the noise or cosmetic performance. It will however be monitored and investigated further in Paranal.

Figure 23 shows an uncorrelated 1sec cold image taken during 'all-up tests b'.
