Document Title	Initial Science detector 41 test results
Document Number	
Issue	1.0
Date	17/12/02

Tests have been carried out on the first WFCAM science device (no 41), using 8 parallel channel readouts per quadrant. A summary of the results is as follows

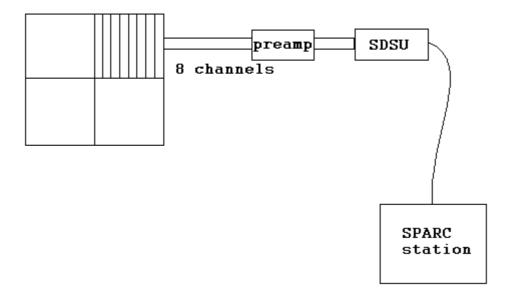
A pulsed IR LED was used for illuminating the detector. Illumination control was achieved by setting the the number of pulses sent to the LED between the two reads of a correlated double sample.

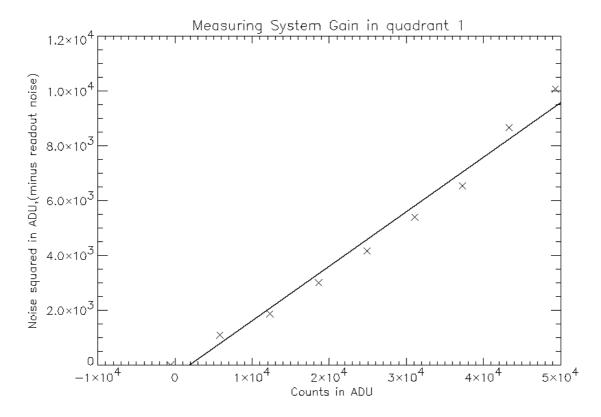
System gain was determined through a photon noise curve as follows. Each Correlated Double Sample frame (CDS) is the result of two reads. The difference of two CDS frames has four lots of read noise, so that

where σ is the standard deviation in the difference of two CDS frames, r is the read noise in a single read and N is the number of photoelectrons detected in each CDS frame, and a is the conversion gain in electrons per ADU. (σ^2 -4r²) was plotted against N. The slope was fitted by linear regression to give the value of 2/a and hence the gain.

System gain averaged over 4 quadrants : 5.2 electrons per ADU Read noise in electrons (for a single read) : 50 electrons

The read noise is currently high, and outside specifications. Investigations are continuing as to its cause.

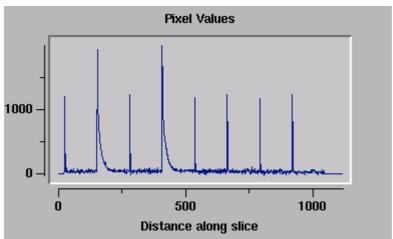
As shown in the cut through the 1024 columns of a quadrant, there seemed to be a glitch associated with the first one or two pixels read out in each row in each CDS frame. The situation is worse in channels 2 and 4 (in this diagram) where the decay occupies 20-40 pixels.

CDS dark frame, 8 channel readout, 1 sec exposure.

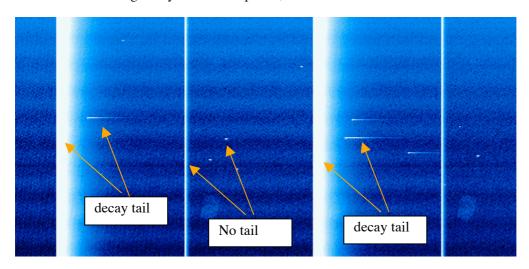
Channels 2 and 4 which appear to have a worse time constant for the decay at the beginning of each row also show a long decay time in hot pixels, which is absent from the other channels as shown here.

Note 15/1/04: Decay tail has been fixed. Due to mistaken capacitance in controller.

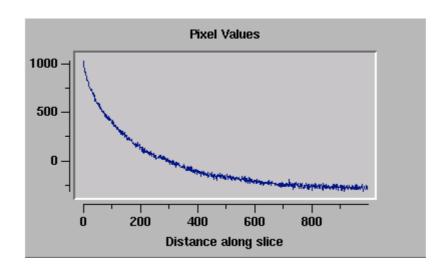
There is also an offset gradient in a CDS frame from top to bottom of each quadrant of the detector of order 1000 ADU. This is illustrated in the following picture and slice from top to bottom of quadrant 4

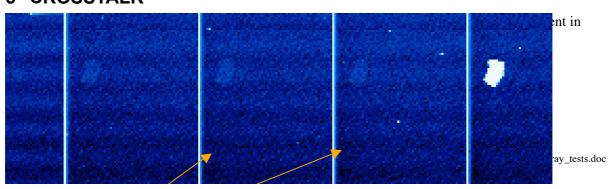
The crosstalk images are weaker by a factor of 1.7E-3 compared to the hot pixels.

The crosstalk is present in ALL quadrants of the detector, even if the controller was not connected to the quadrant having the hot pixel patch. This shows that the crosstalk arises in the detector and not the

crosstalk between channels and quadrants is at the level of 1.7E-3. The crosstalk arises in the detector rather than the controller.

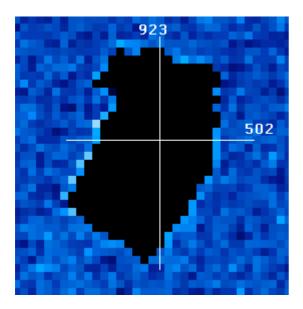
Two particularly bad areas stand out. The first is a dead pixel area in quadrant 2 at position (923,502). This is shown here.

An estimated 317 pixels in the patch have QE<10% of the median QE.

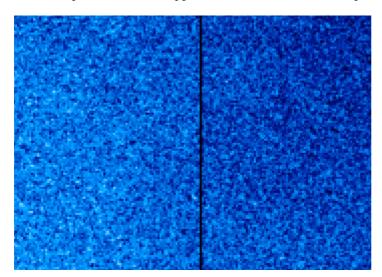
A second problem is what appears to be a dead column in quadrant 4 at column 408.
